Independent Monitoring Committee – Community Liaison Committee

Task 12 - Provide comment on the progress of the Botany Groundwater Cleanup Project to date

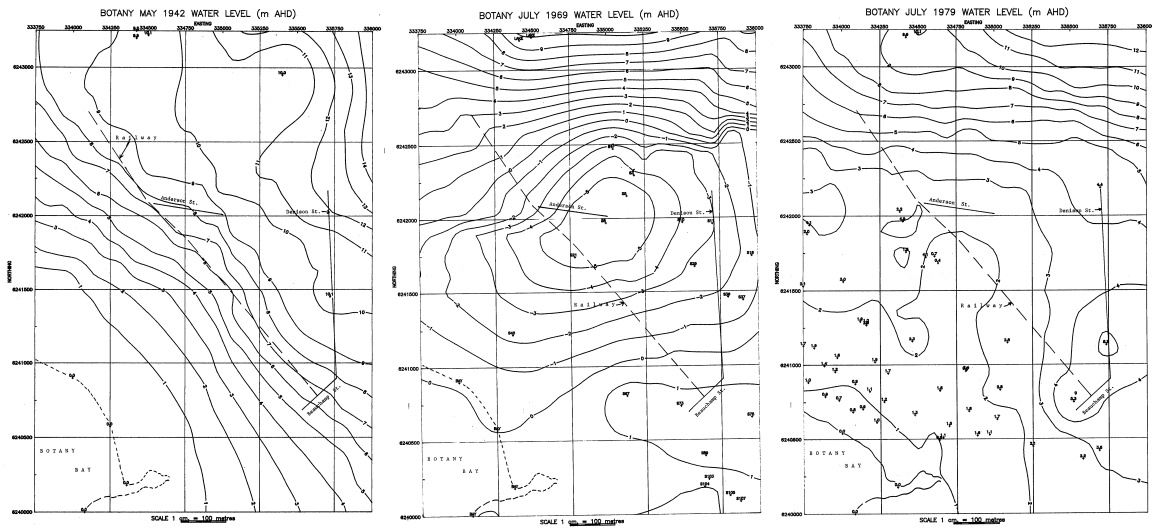
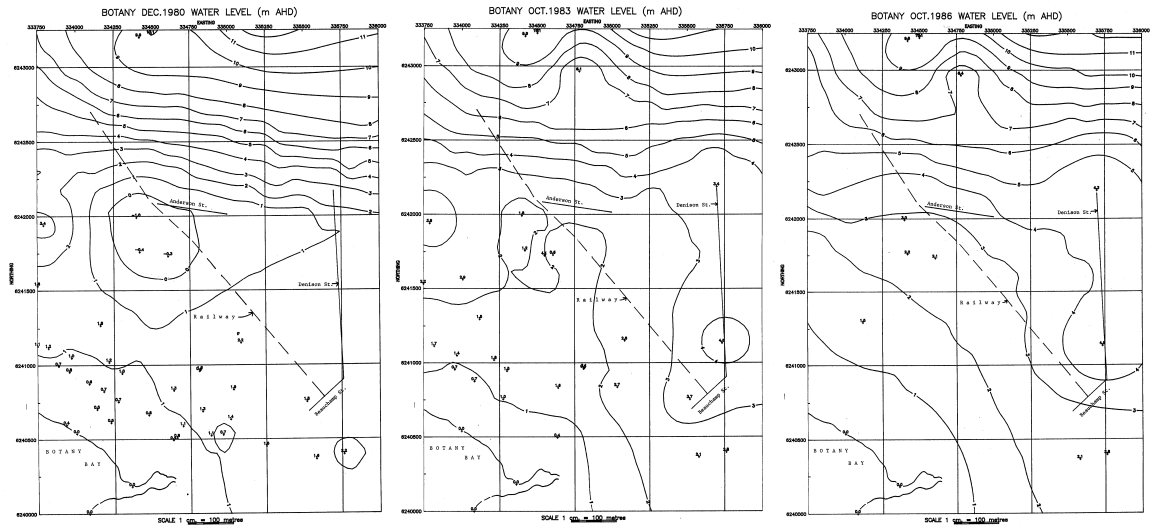
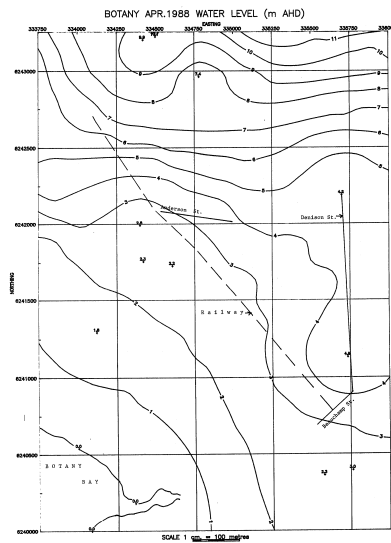
Task 5 - Botany Aquifer Levels – showing the development of a cone of depression due to over pumping and the recovery that occurred when pumping was stopped.
