Settlement Monitoring
Orica Botany Groundwater
Remediation
Report No.1

Orica Engineering Pty Ltd

8 December 2005

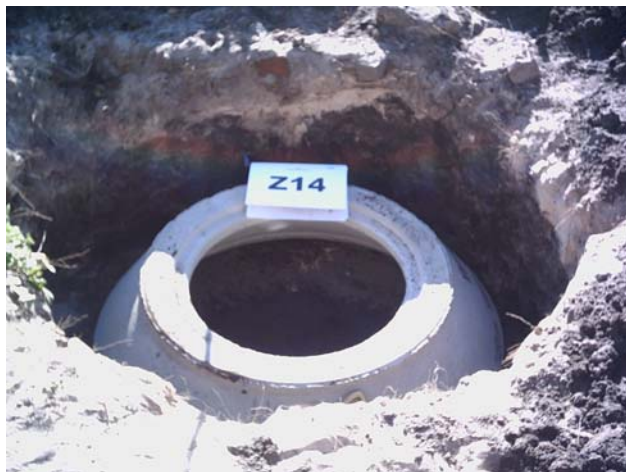
Plate 2.1

Excavation complete, base section of maintenance hole installed.

An example of the stages of construction/installation, photographed at settlement plate Z14, is presented below in Plates 2.1 to 2.4.

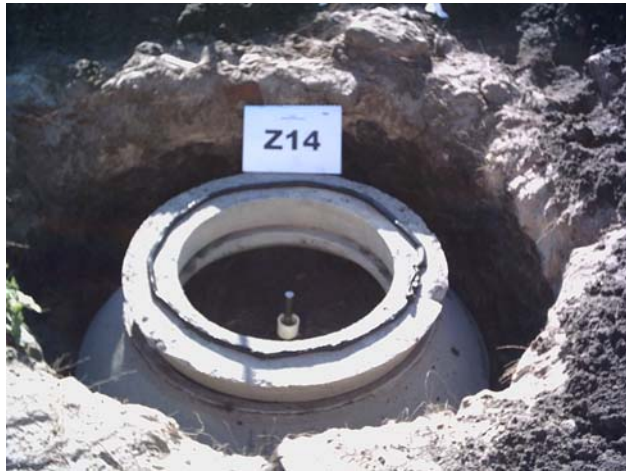
Plate 2.2

Settlement plate installed and backfilled.

The settlement plate is a steel plate 0.4 m long x 0.4 m wide x 0.006 m thick with a 0.4 m long x 0.025 mm diameter steel rod welded to the centre of the plate. A Work Method Statement (presented as a Memorandum) attached in Appendix A outlines the method used to install the majority of the settlement plates. The excavation work was undertaken by BCP using hand tools only, supervised by URS. Placement of the chamber sections was carried out by a backhoe with appropriate chain lengths and lifters. The backhoe was not be used for excavation purposes.

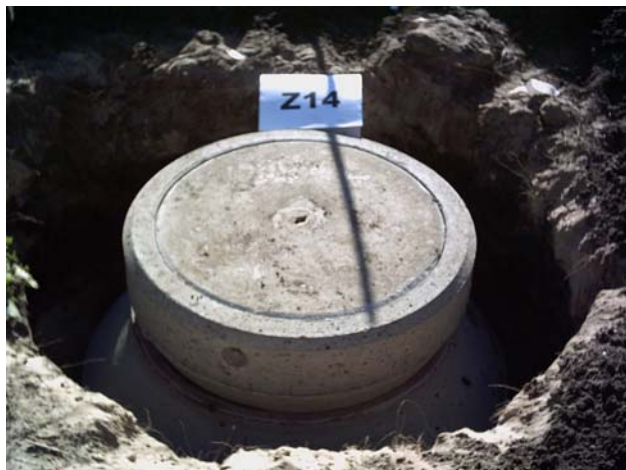
Plate 2.3

Top/lid section of maintenance hole installed.

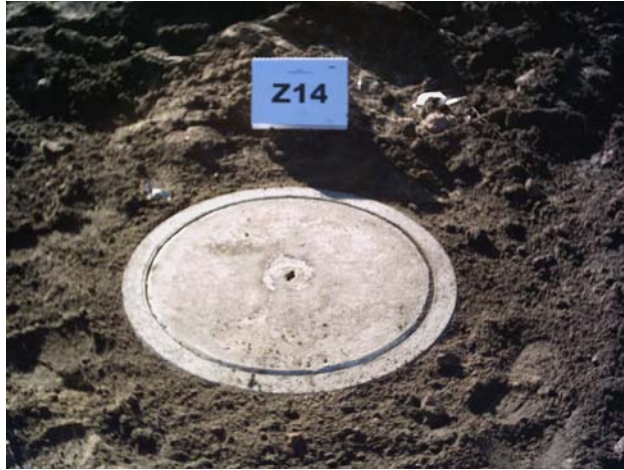
Plate 2.4

Backfill complete.

Due to the heavy vehicles which often cross the Foreshore Road median strip, settlement plates Z18, Z19 and Z20 were placed and backfilled within purpose-designed and engineered concrete chambers of similar specification to the groundwater extraction well housings. Whilst the housing for the settlement plates on Foreshore Road was different to that for the other settlement plates (illustrated in the above plates), the method of installation of the plates themselves was the same.
